Kootowis, Staghorn, Lost Shoe and Sandhill Creek Instream Restoration

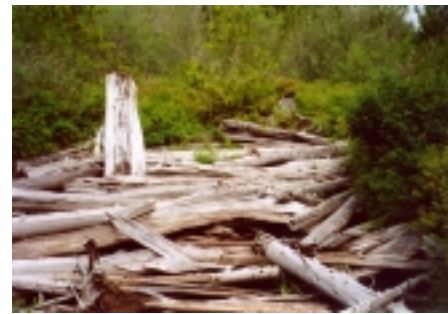
Figure 1 Pre restoration view of Staghorn East Fork looking downstream at Jam 27 (1+751).

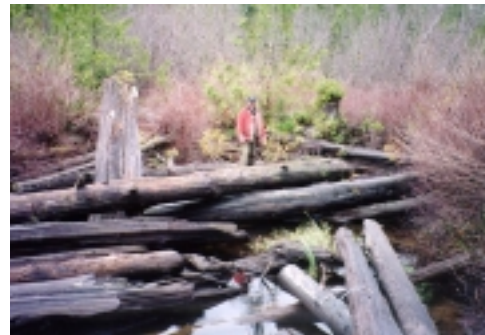
Figure 2 Post restoration view of Staghorn East Fork looking downstream at Jam 27 (1+751).
