Kootowis, Staghorn, & Lost Shoe Creek 2000 Watershed Restoration

The objective of this project was to remove and/or rearrange extensive clusters of logging debris that had blocked or reduced the usable instream salmonid habitat, and add LWD to deficient reaches.

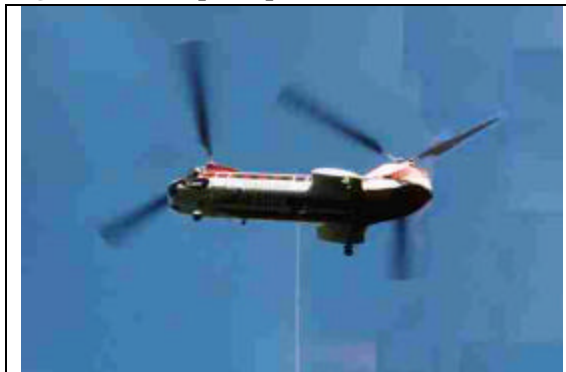
Figure 1 Helicopter operations.

Helicopters were used to remove wood waste from wide floodplains but to add LWD to deficient areas. Coordinating with a nearby heli-logging show, the Helifor Vertol flew approximately fifty 5-10 m long logs (donated by Interfor and MOF) into Staghorn Creek in less than 1.0 hour.

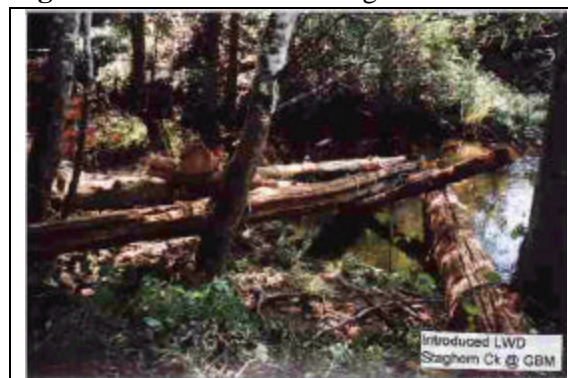
Figure 2 Restored area of Staghorn

A total of 12.2 kilometers of stream length or approximately 61,000-m² area was restored. Work area was determined utilizing a risk assessment methodology (Warttig 1999) that prioritizes where work should occur. The restoration method was to remove all of the loose small wood debris (SWD) blocking the stream flow around the Large Wood Debris (LWD) and then to rearrange or add additional LWD if necessary to the benefit of salmonid habitat.
