Project:Kootowis Creek Riparian Restoration

Enhancement of Riparian Forests in the Kootowis Creek Watershed

December 2000

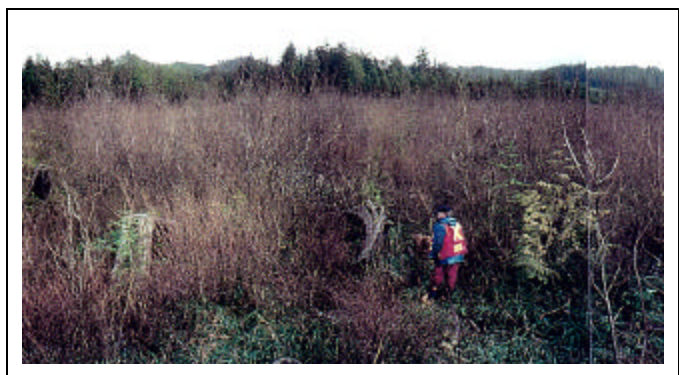
RVT 1: understocked conifer site dominated by brush

RVT 1, prior to restoration

- altering current stand densities and species compositions by hand falling and spacing of retained trees.
- releasing conifers in brush dominated areas by removing competing shrubs.
- planting rapidly growing Black Cottonwood trees along shade deficient areas of Kootowis Creek.
- restoring wildlife habitats associated with old forest characteristics by girdling, topping, and top-girdling trees; and recreating cavities and slots in trees for use by birds, bats and mammals.
