Viner River Instream and Riparian Restoration Project, 2001

This project is the first phase of a series, designed to provide stable channel structure and a defined channel thalweg. The production of holding and spawning habitat for chum salmon (*Oncorhynchus keta*) as well as rearing and refuge habitat for coho (*Oncorhynchus kisutch*), rainbow (*O. mykiss*) and cutthroat trout (*O. clarki*) is anticipated as a secondary outcome.

Rehabilitation Work

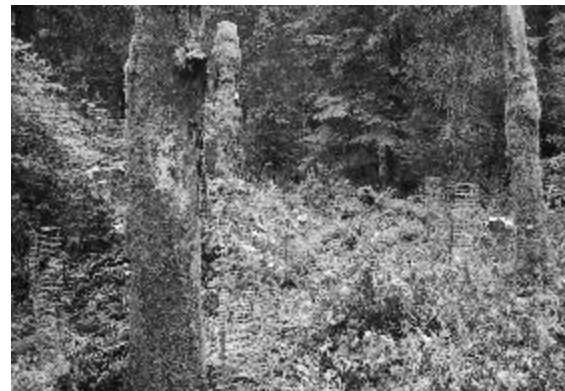
Riparian: Site brushed and cedars planted in cages, Aug. 2001

The restoration of the riparian zone along Reach 2 was fully completed with additional work completed within Reach 1, 3 and 4 as well. A total of 4.7 ha of riparian vegetation type (RVT) 4, "deciduous forest over top a poor conifer understory" was treated. This involved brushing, thinning and girdling patches of alder, and clump planting 3,500 cedar. These cedars were all large 2+0 high-quality 620 stock. All cedars planted were wire caged and staked to prevent deer damage. Up to 1000 naturally regenerating spruce and hemlock were also released from salmonberry and alder competition.

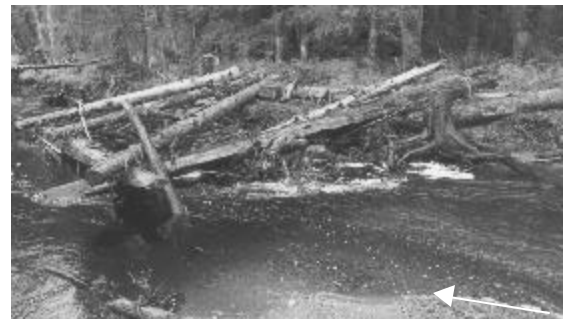
Instream: Typical A-frame LWD Structure, December 2001

The extent of instream restoration was limited by funding. Despite this, seven LWD structures were constructed within Reach 2. Five of the structures were double a-frame structures utilizing 6 or 7 logs and at least 3 stumps each. In addition to these structures two logs were added to enhance an existing logjam and two logs were added to a flood channel gravel bar site to reduce flood velocities and promote revegetation

A B-Star helicopter with a maximum payload of 2400 lbs. was used to import all materials for the project. A total of 55 pieces of LWD were imported including 35 logs and 20 stumps. Forty one boulders were incorporated into the structures with a total weight of 26 400 kg. The

boulders were cabled to the structures to provide structural ballast and to enhance habitat complexity. The structures were lashed together using 5/8" steel cable.
